STUDY OF THE SAFETY OF GABION STRUCTURES IN THE CONDITIONS OF URBAN ENVIRONMENT

Abstract. The present work is devoted to the study of the safety of gabion structures in an urban environment on the example of bank protection of a pond near “Piramida” shopping center in Samara. Based on current regulatory documents, the safety level for humans at the construction and operation stage was estimated, as well as for the environment. It has been shown that the quality of work performed has a significant impact on the level of safety. Violations of the requirements of regulatory documents allowed during the construction of the structure led to the emergence of risks for the townspeople, as well as to a decrease in the quality of the pond water.

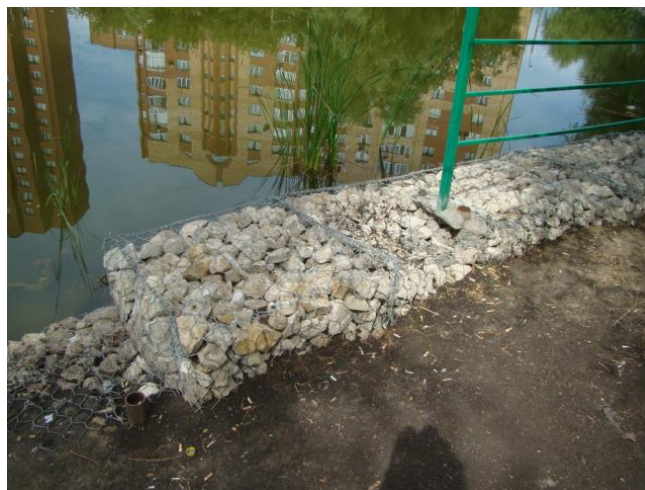
Fig. 1. Fragment of gabion structures

As shown by the results of gabion structures survey of the pond shore protection near the Pyramid Shopping Center, a year after the commissioning of the facility damage and deformation of the mesh, as well as settlement of the filler are noticeable (Fig. 1).

This is the result of a gross violation of the abovementioned regulatory requirements for the gritter: carbonate rocks are used, which being in a zone of the variable level, are the subject of rapid destruction, which will inevitably affect on the level of gabions safety in the operational stage. The requirement for aggregate size of the stone was also ignored.
